Tree Inventory and Preservation Plan Report 895 Lawrence Avenue East Toronto, Ontario

28 June 2022; revised 28 June 2023

KUNTZ FORESTRY CONSULTING INC. Project P3327

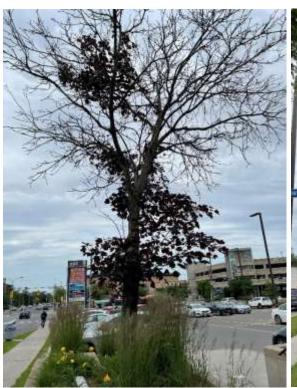
Image 1. Tree 663 Image 2. Tree 664

The removal of all three trees, including Trees 663 - 665, is required to accommodate the proposed development. Tree 664 is greater than 30cm DBH and is located on the subject property (Category 1) and as such, a permit is required prior to its removal.

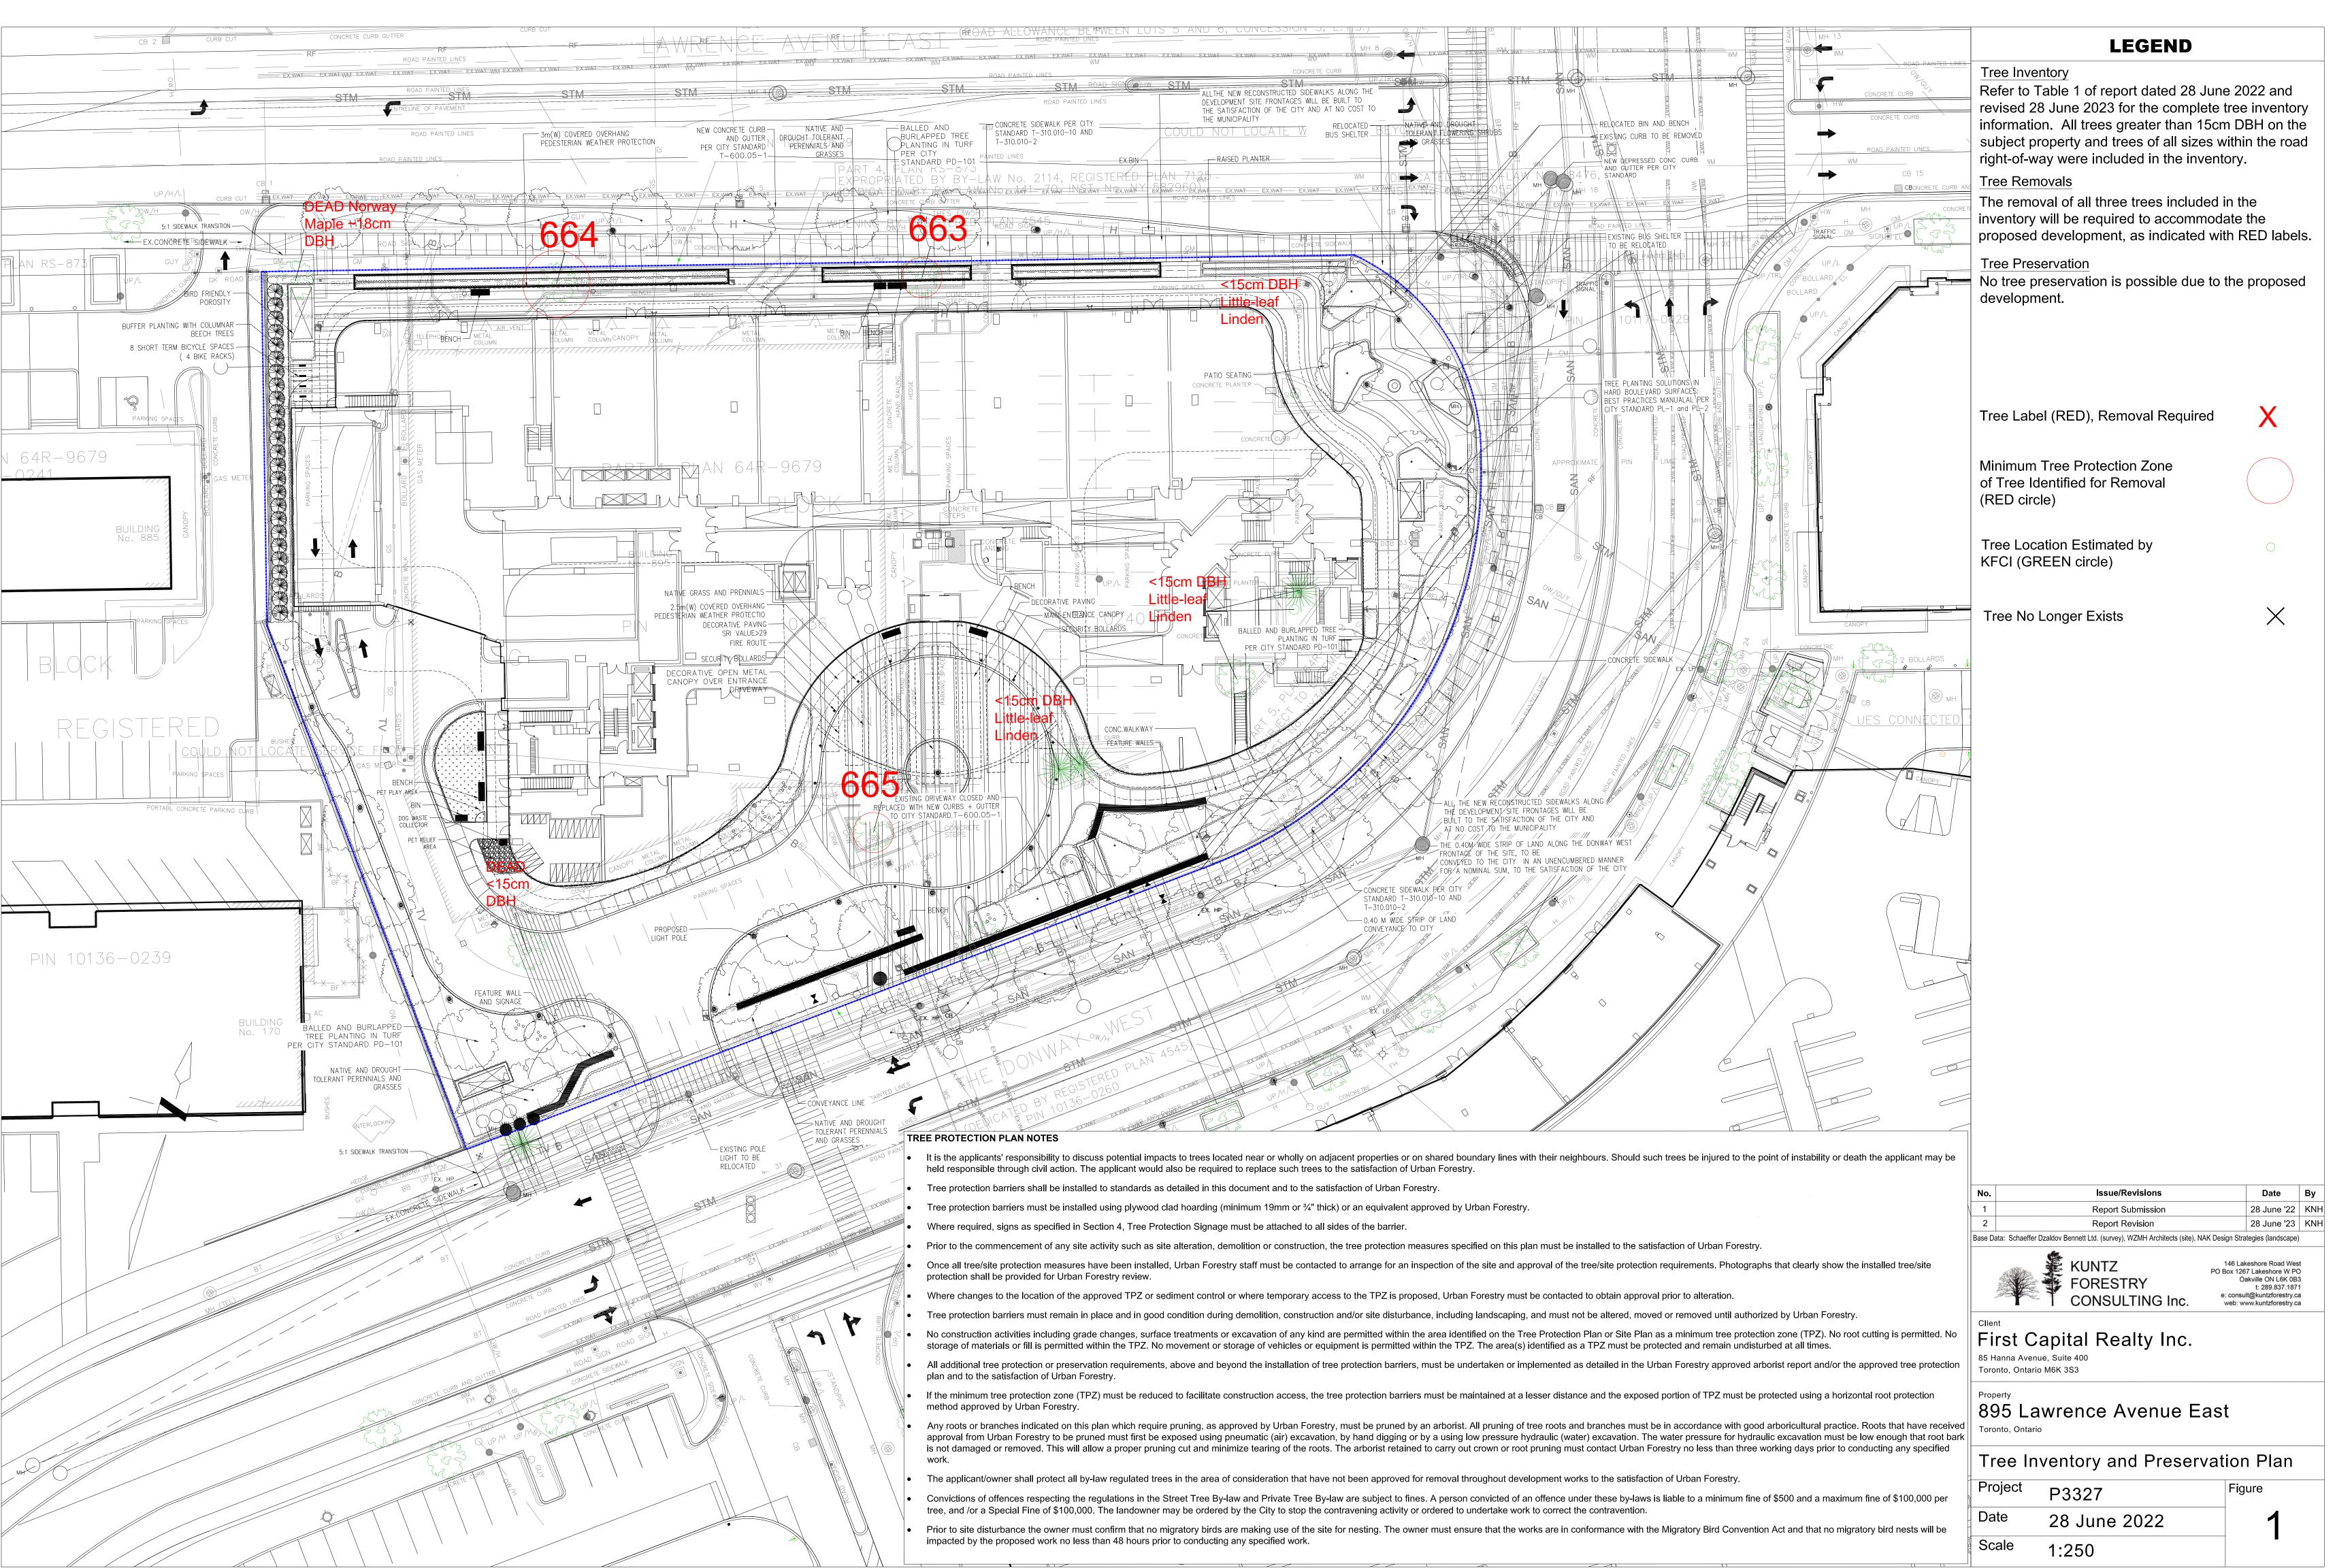
The tree inventory was conducted on 20 June 2022. The inventory documented three trees on and adjacent to the subject property. Refer to Table 1 for the full tree inventory and Figure 1 for the location of trees reported in the tree inventory.

Refer to Figure 1 for the location of tree removals.
