Tree Inventory and Preservation Plan Report 895 Lawrence Avenue East Toronto, Ontario

28 June 2022; revised 28 June 2023

KUNTZ FORESTRY CONSULTING INC. Project P3327

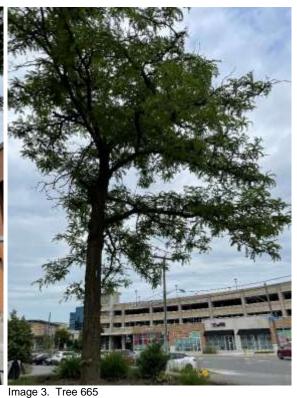
Image 1. Tree 663 Image 2. Tree 664

Tree #	Common Name	Scientific Name	DBH	TI	cs	cv	CDB	Cat.	mTPZ	Comments	Action
663	Crimson King Norway Maple	Acer platanoides 'Crimson King'	20	F	PF	PF	60	-	1.8	Pruning wounds (L) with decay (L), epicormic branching (M), deadwood (M)	Remove
664	Shademaster Honey Locust	Gleditsia triacanthos 'inermis'	44	FG	G	G		1	3.0	Burls (L), bow (VL)	Remove
665	Shademaster Honey	Gleditsia triacanthos	23	G	FG	G		-	1.8	Pruning wounds (L), asymmetrical crown (L)	Remove
